Contract #: 04-0120F4Cty: SF/ALA Rte: 80 PM: 13.2/13.9File #: 13.28**WELDING INSPECTION REPORT****Resident Engineer:**Pursell, Gary**Address:** 333 Burma Road**City:** Oakland, CA 94607**Report No:** WIR-005308**Date Inspected:** 30-Jan-2009**Project Name:** SAS Superstructure**OSM Arrival Time:** 700**Prime Contractor:** American Bridge/Fluor Enterprises, a JV**OSM Departure Time:** 1730**Contractor:** Oregon Iron Works Clackamas, Or.**Location:** Clackamas, Oregon**CWI Name:** See below**CWI Present:** Yes No**Inspected CWI report:** Yes No N/A**Rod Oven in Use:** Yes No N/A**Electrode to specification:** Yes No N/A**Weld Procedures Followed:** Yes No N/A**Qualified Welders:** Yes No N/A**Verified Joint Fit-up:** Yes No N/A**Approved Drawings:** Yes No N/A**Approved WPS:** Yes No N/A**Delayed / Cancelled:** Yes No N/A**Bridge No:** 34-0006**Component:** Hinge K Pipe Beams**Summary of Items Observed:**

## WELDING INSPECTION REPORT

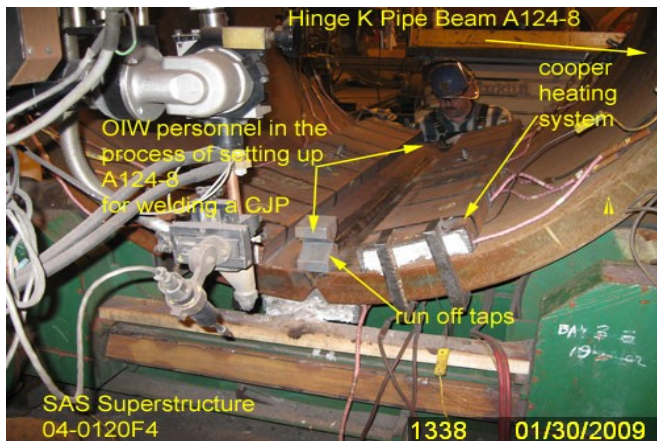
The following digital photograph below illustrates observation of the activities being performed.
